Situation Photo Log

Tuesday, January 15, 2013

Kalamazoo River / Enbridge Spill

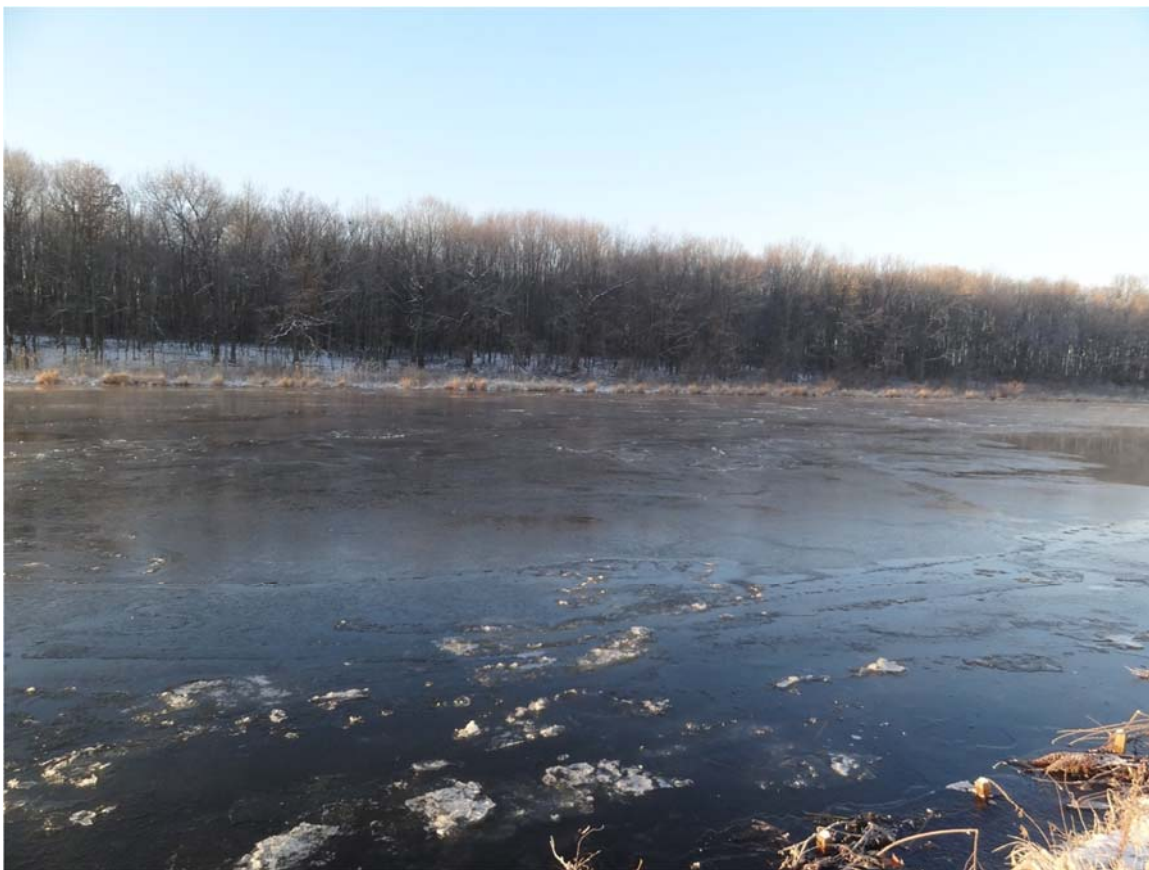
1. C0.4 Boat launch observed sheets of ice flowing within the river.

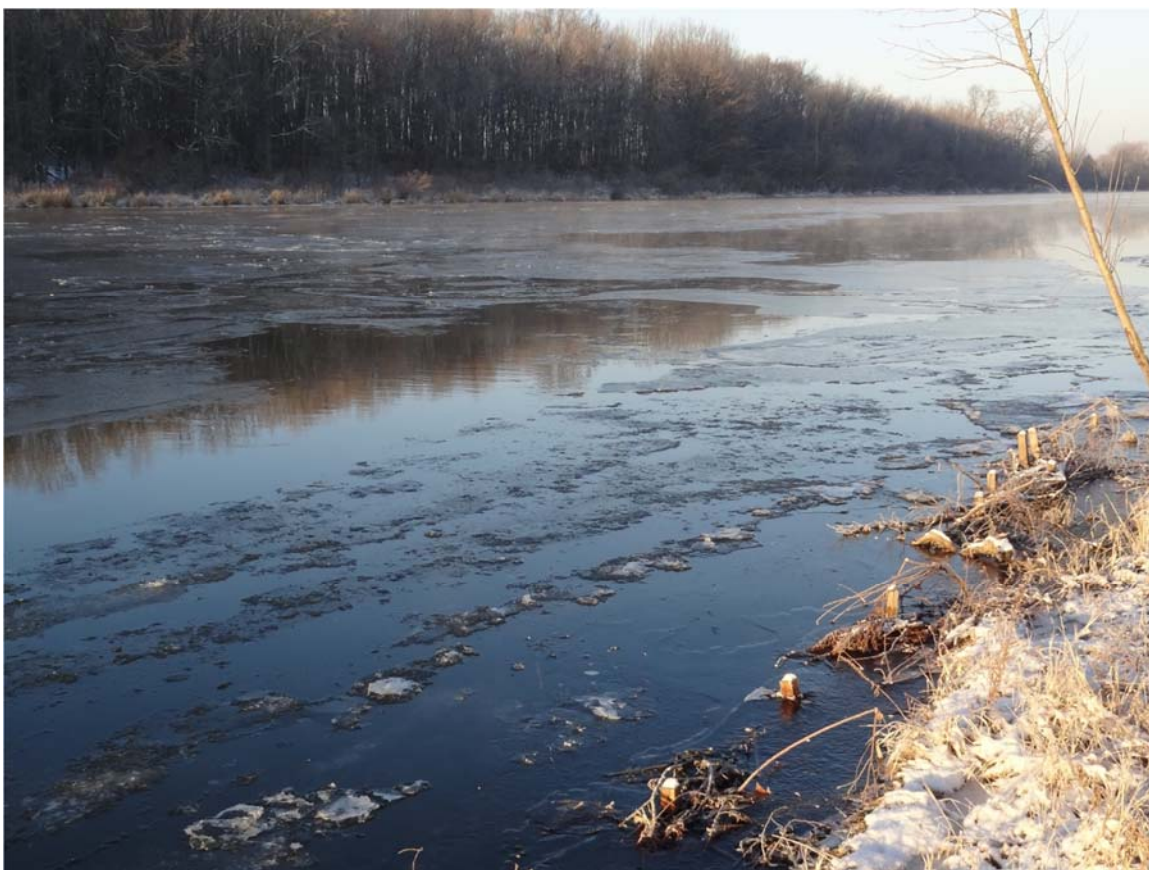
2. C0.4 Boat launch observed sheets of ice flowing within the river.

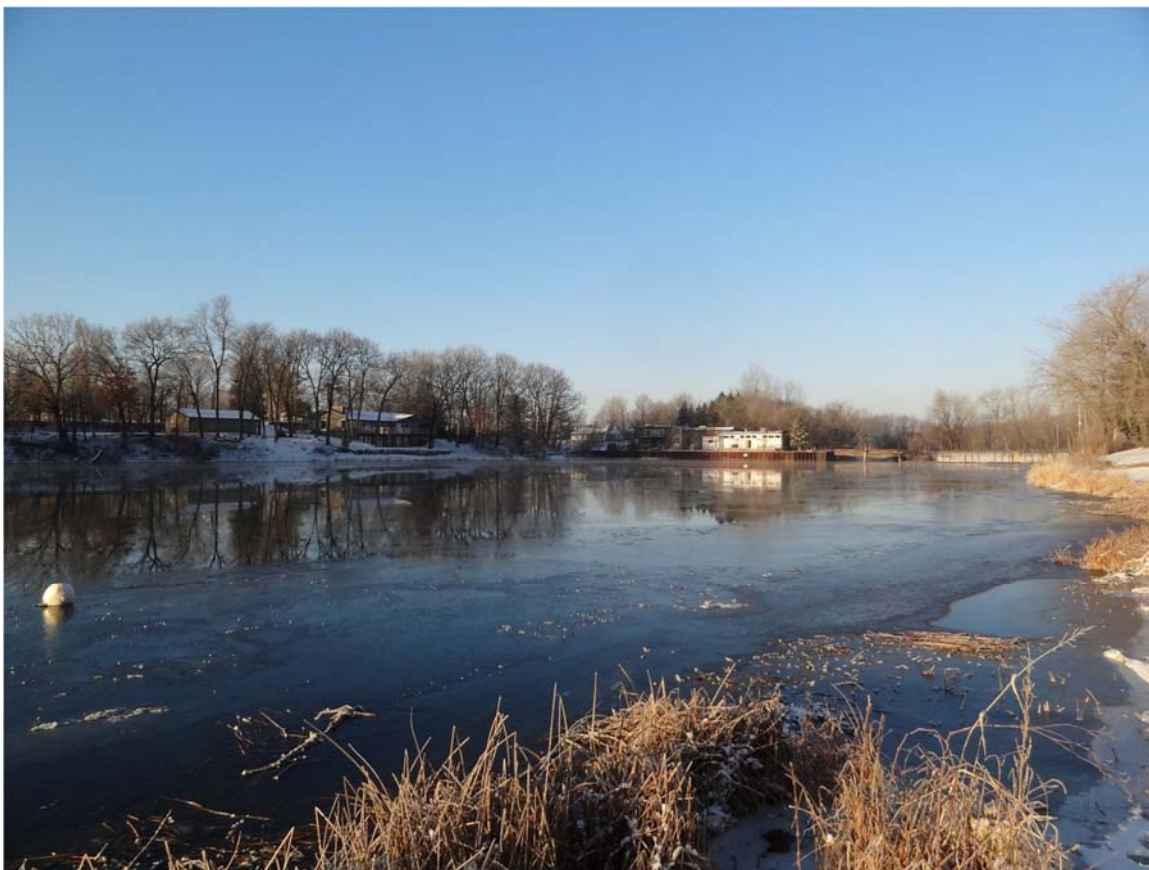
3. Ceresco Dam impoundment icing conditions.

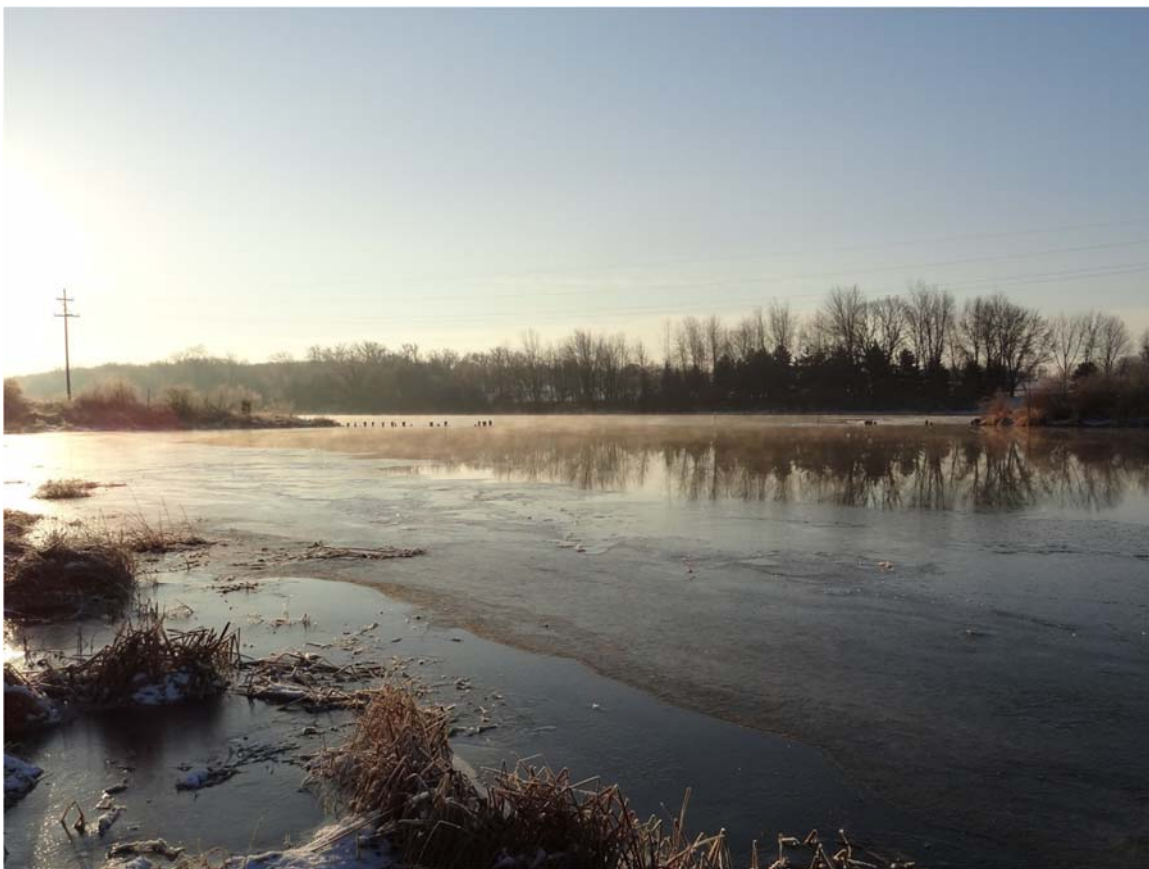
4. Ceresco Dam impoundment icing conditions.

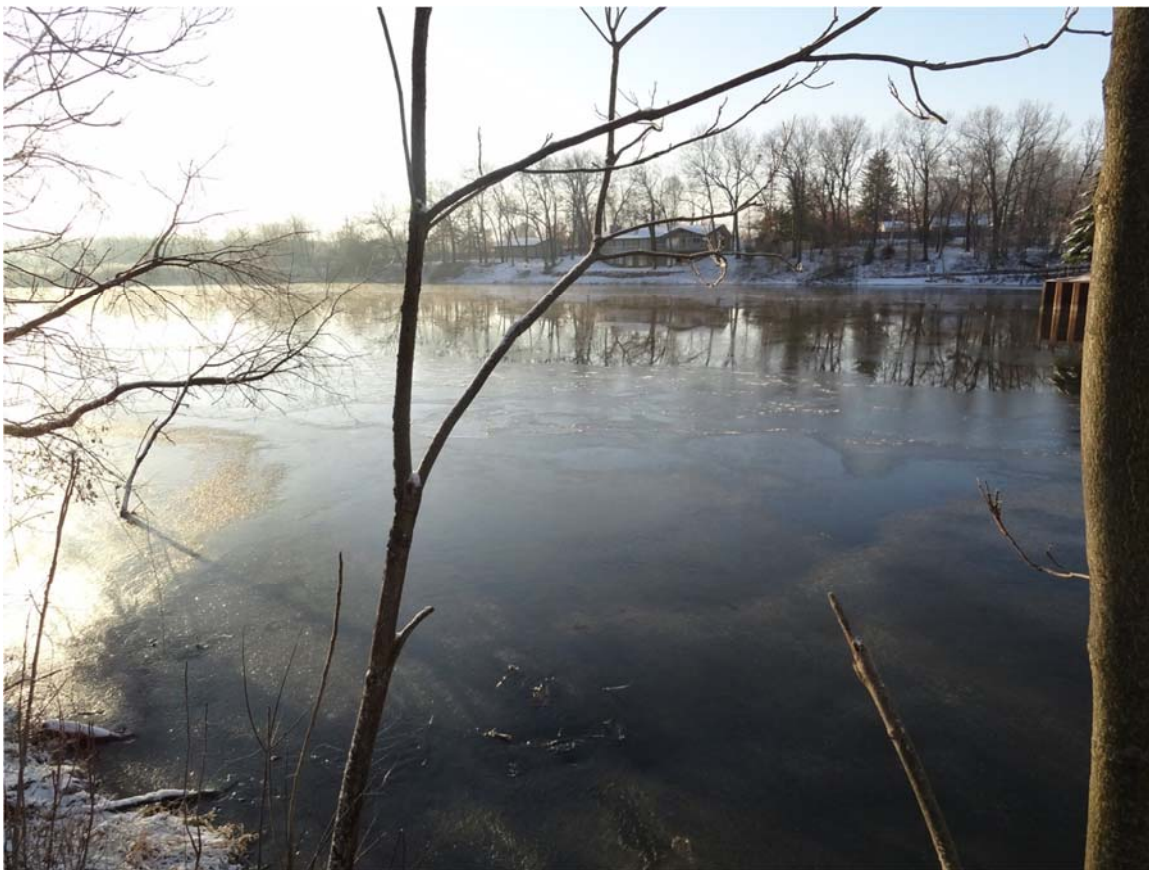
5. Ceresco Dam impoundment icing conditions.

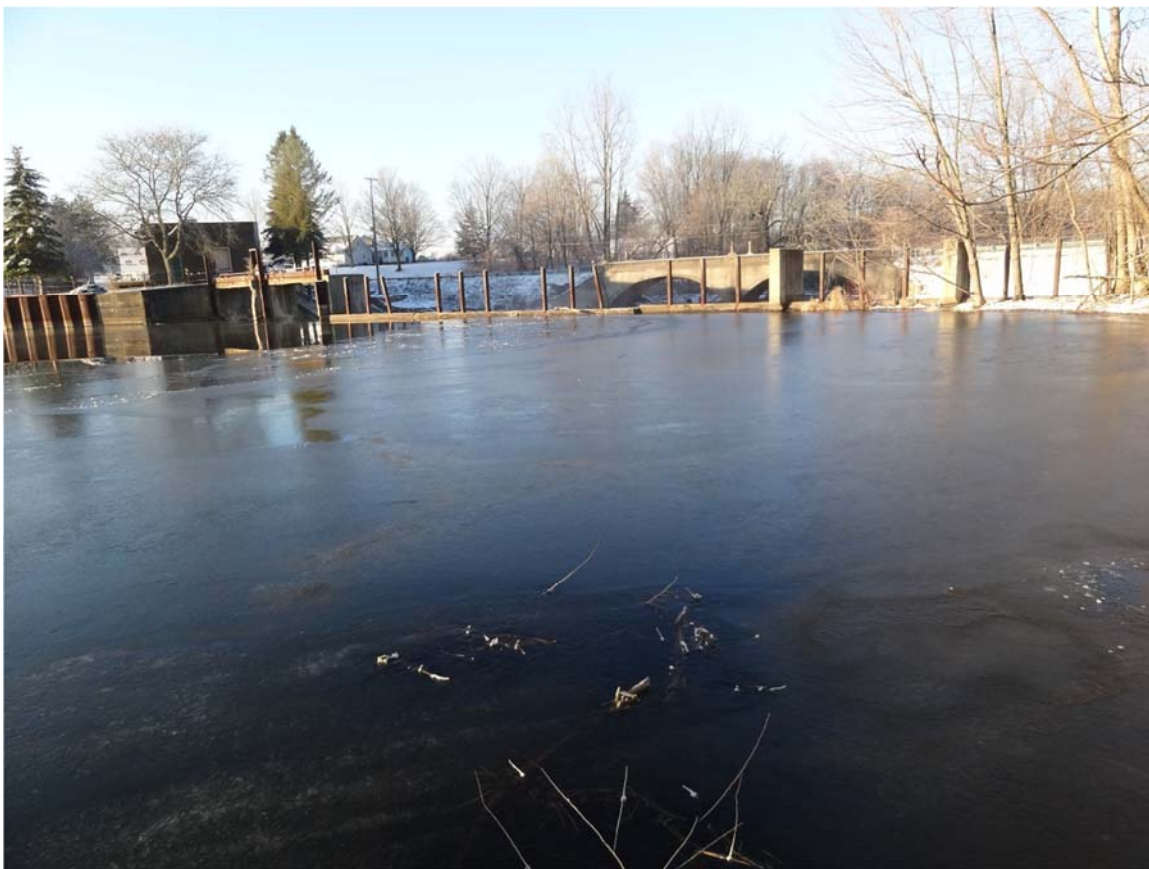
6. Ceresco Dam impoundment icing conditions.

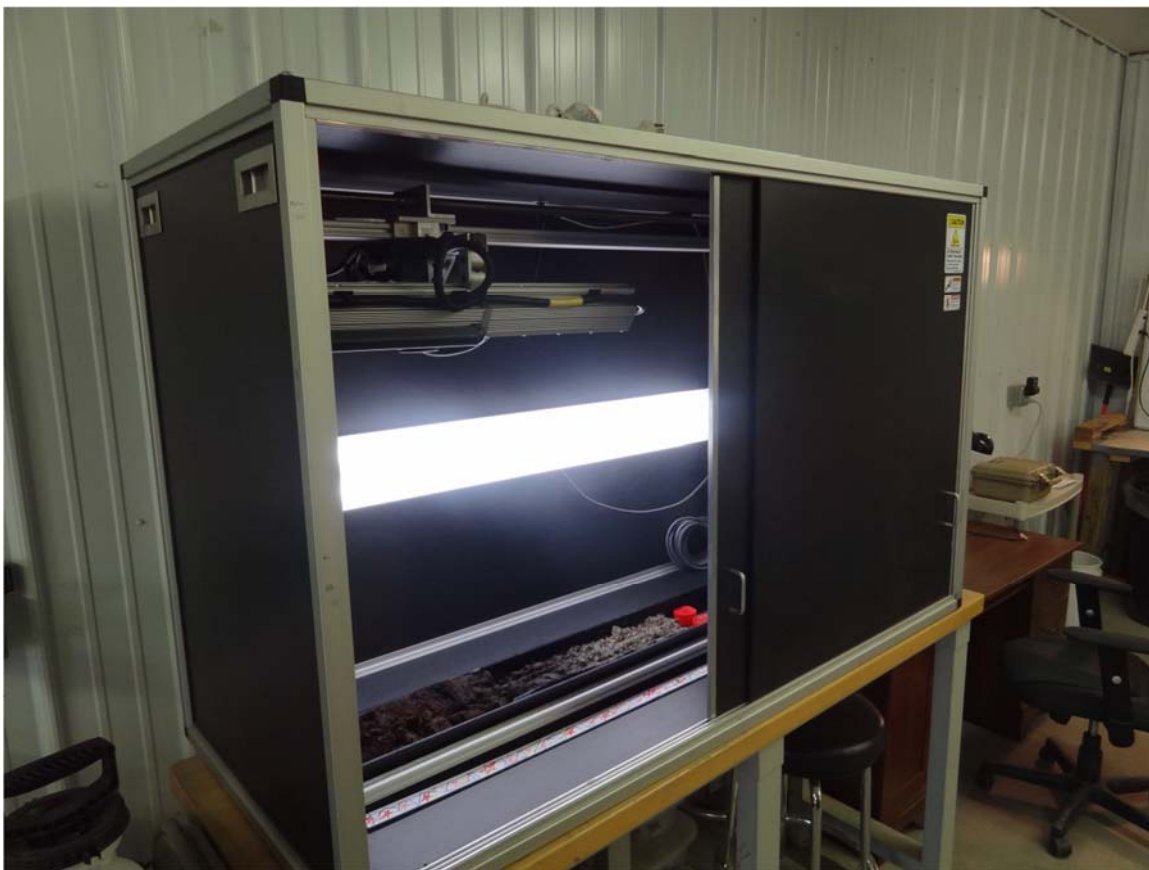
7. Observed core logging in the C3.2 pole barn.

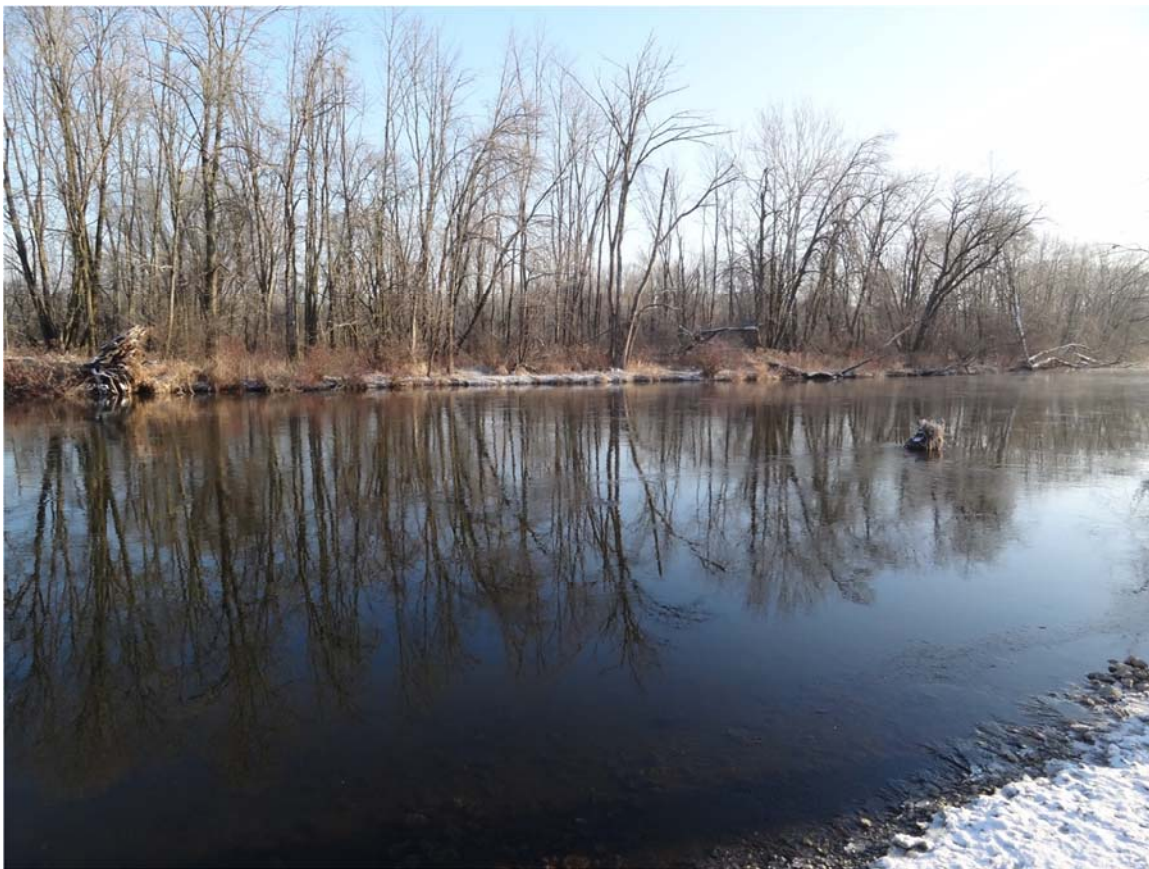
8. C3.2 Boat launch observed sheets of ice flowing within the river.

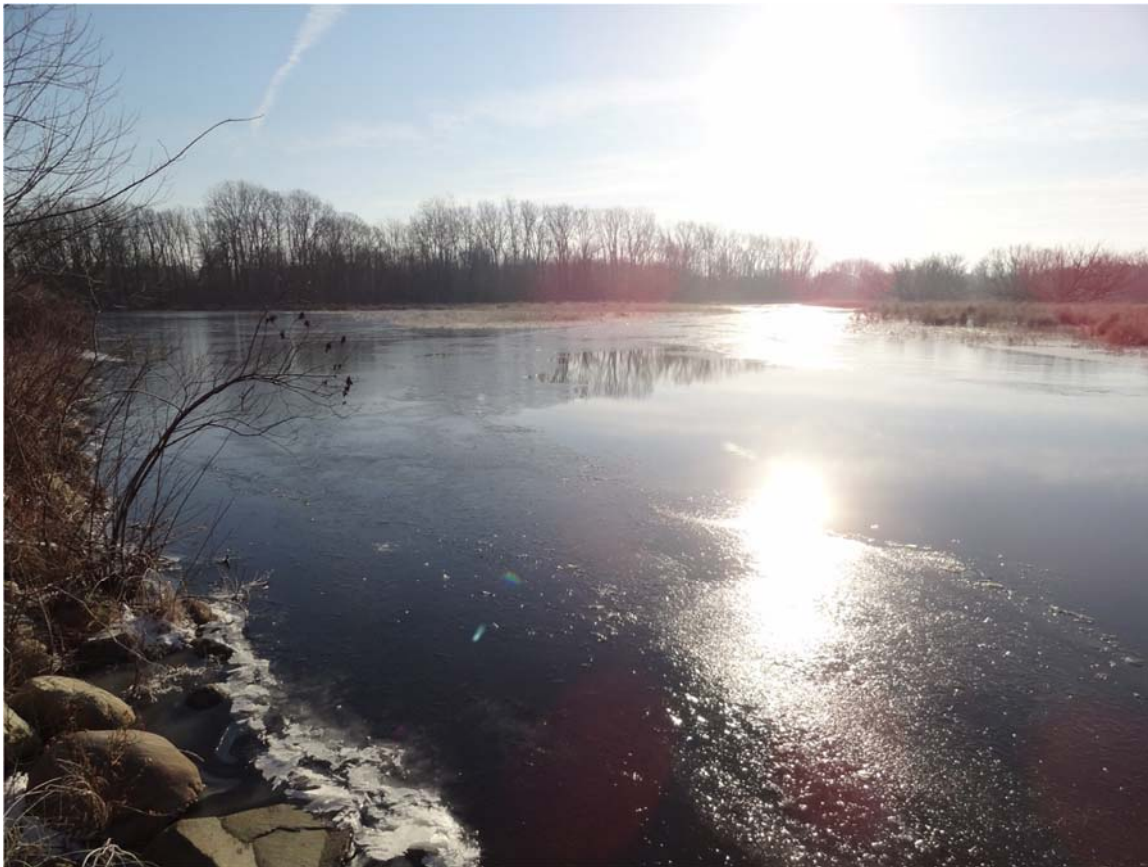
9. MP15.25 South Mill Pond observed ice forming.

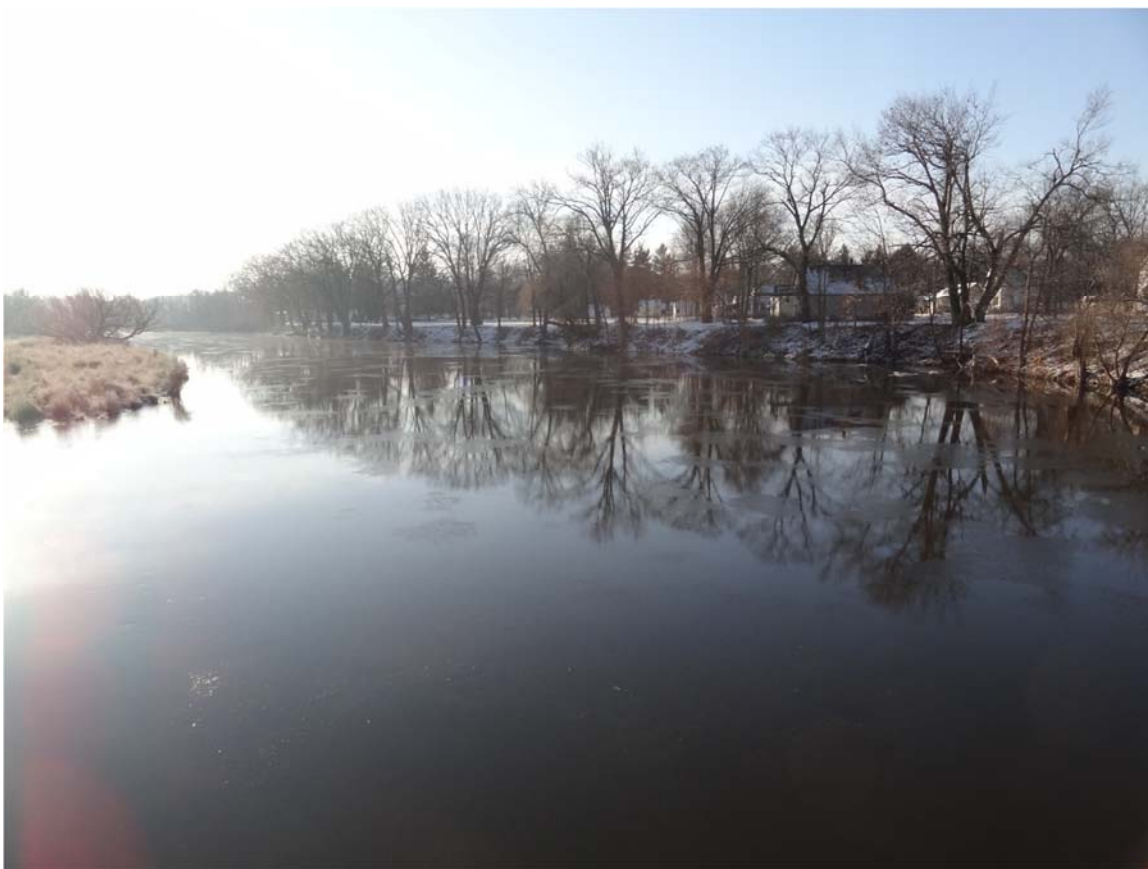
10. MP15.25 South Mill Ponds observed sheets of ice flowing within the river.

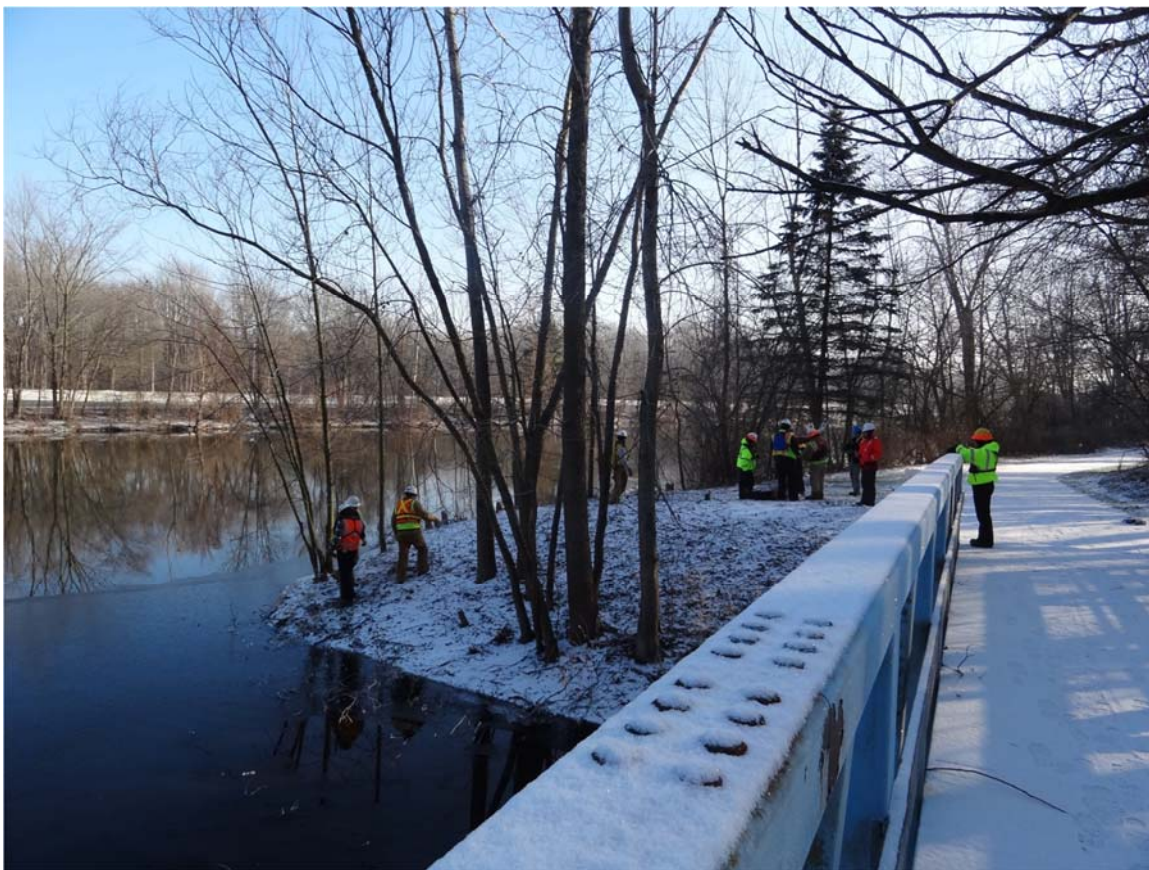
11. MP19.0 LDB observed an RI crew.

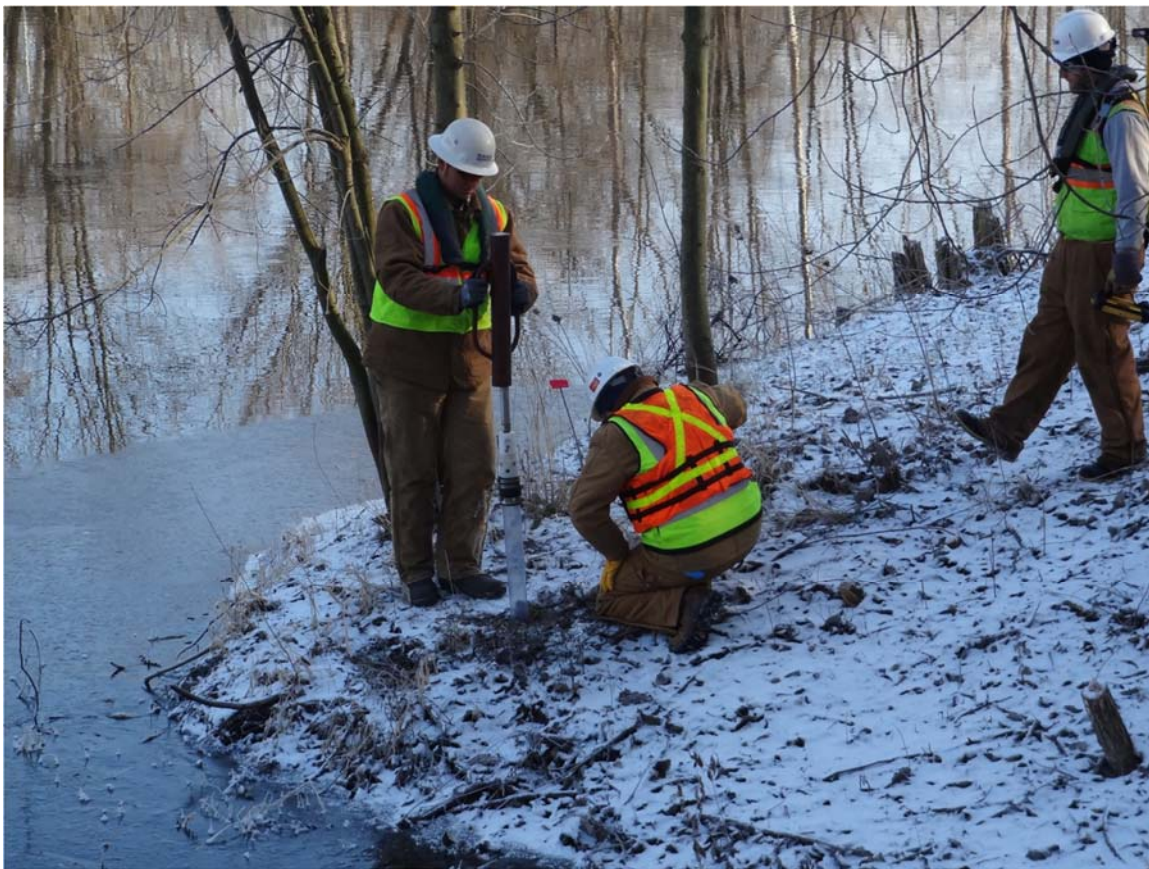
12. MP19.0 LDB observed an RI crew.

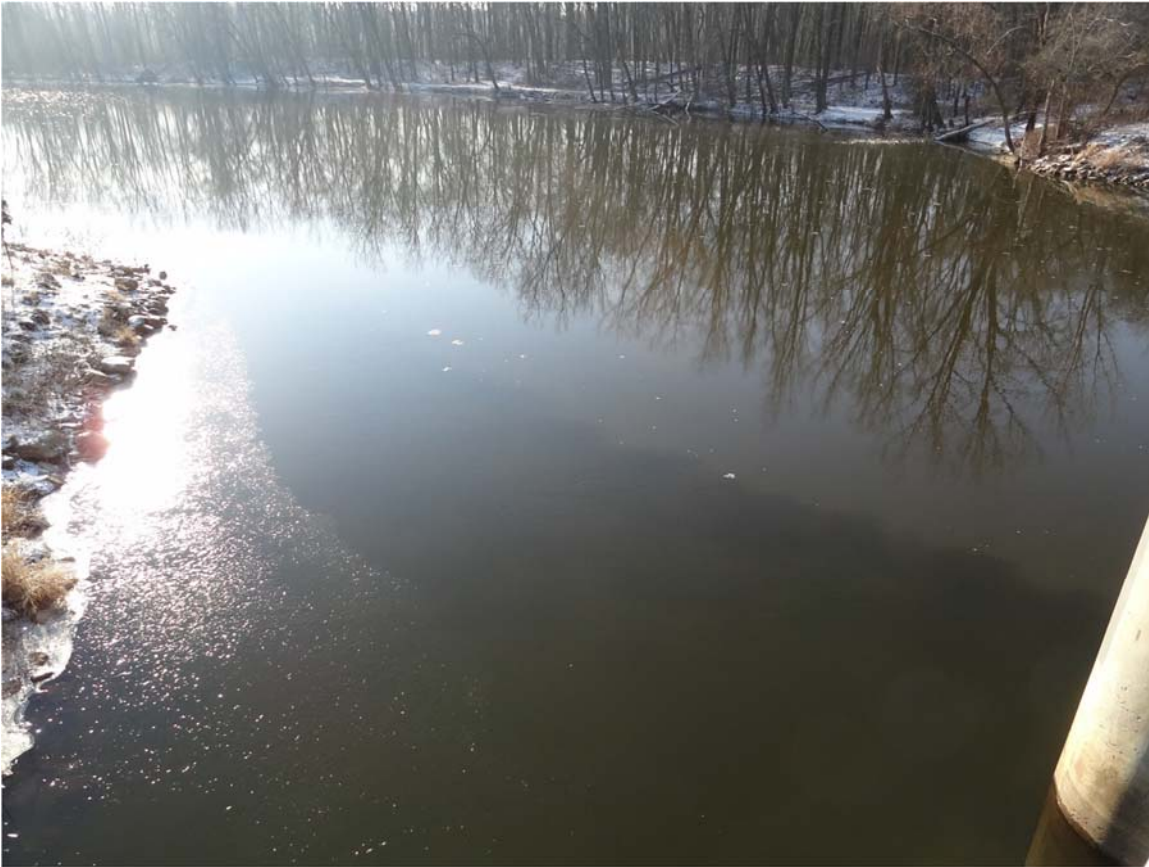
13. MP21.5 Custer bridge observed turbidity in the river. No ice observed flowing within the river.

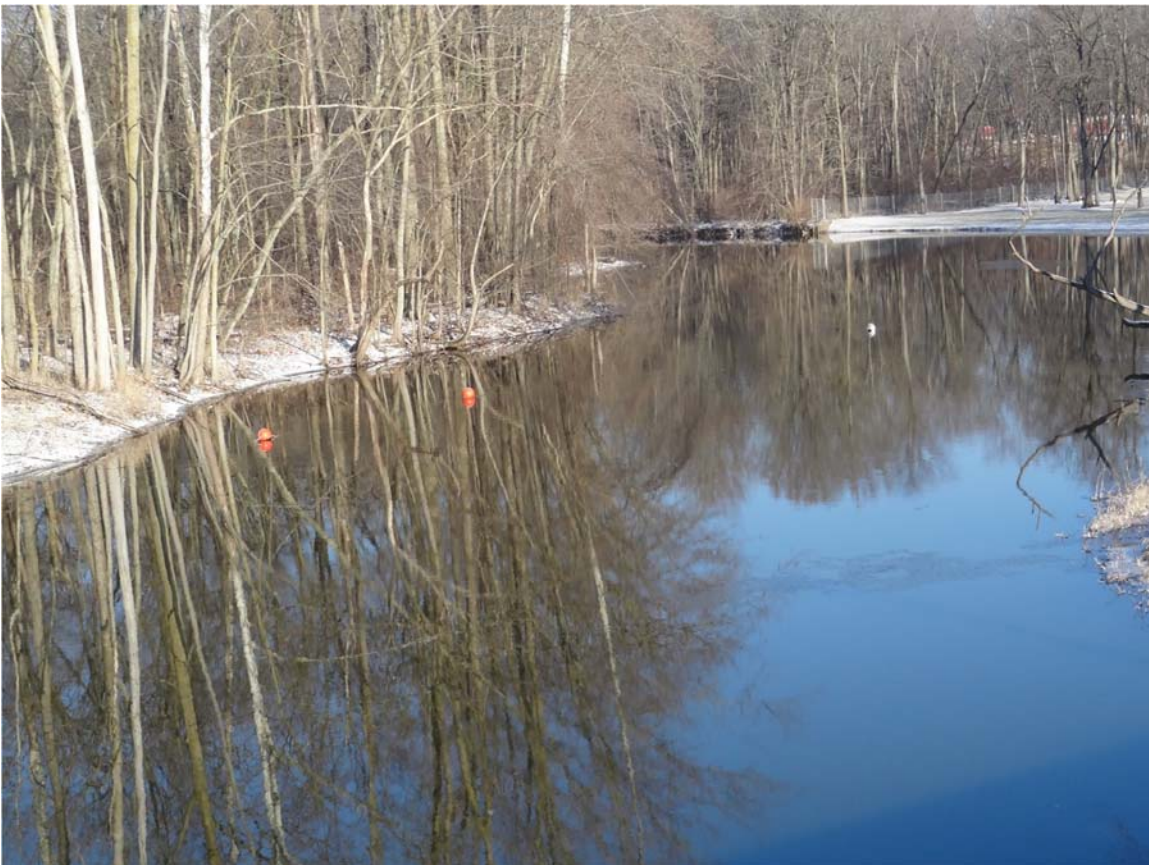
14. MP21.5 Oxbow observed the marker buoys dislodged.

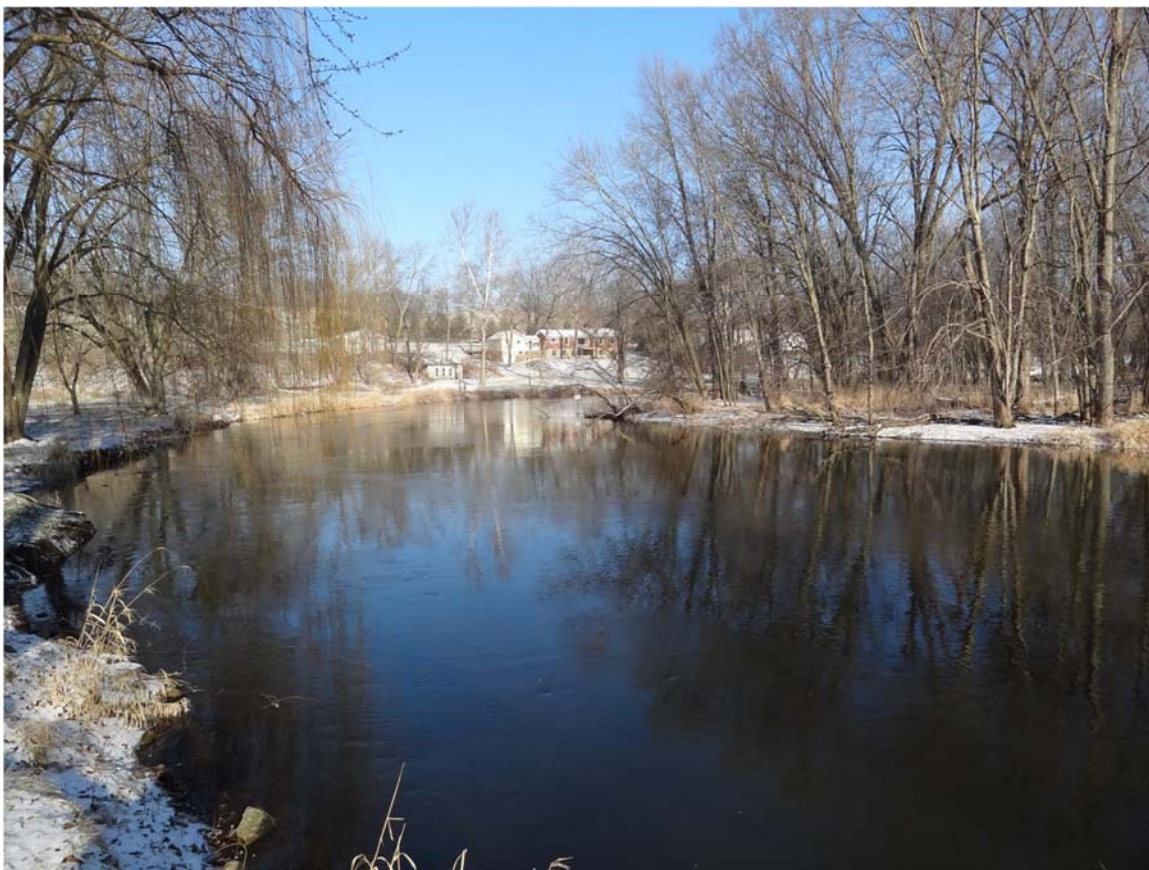
15. E0.5 Boat Launch Shadybend Campground river conditions. No ice observed flowing within the river.

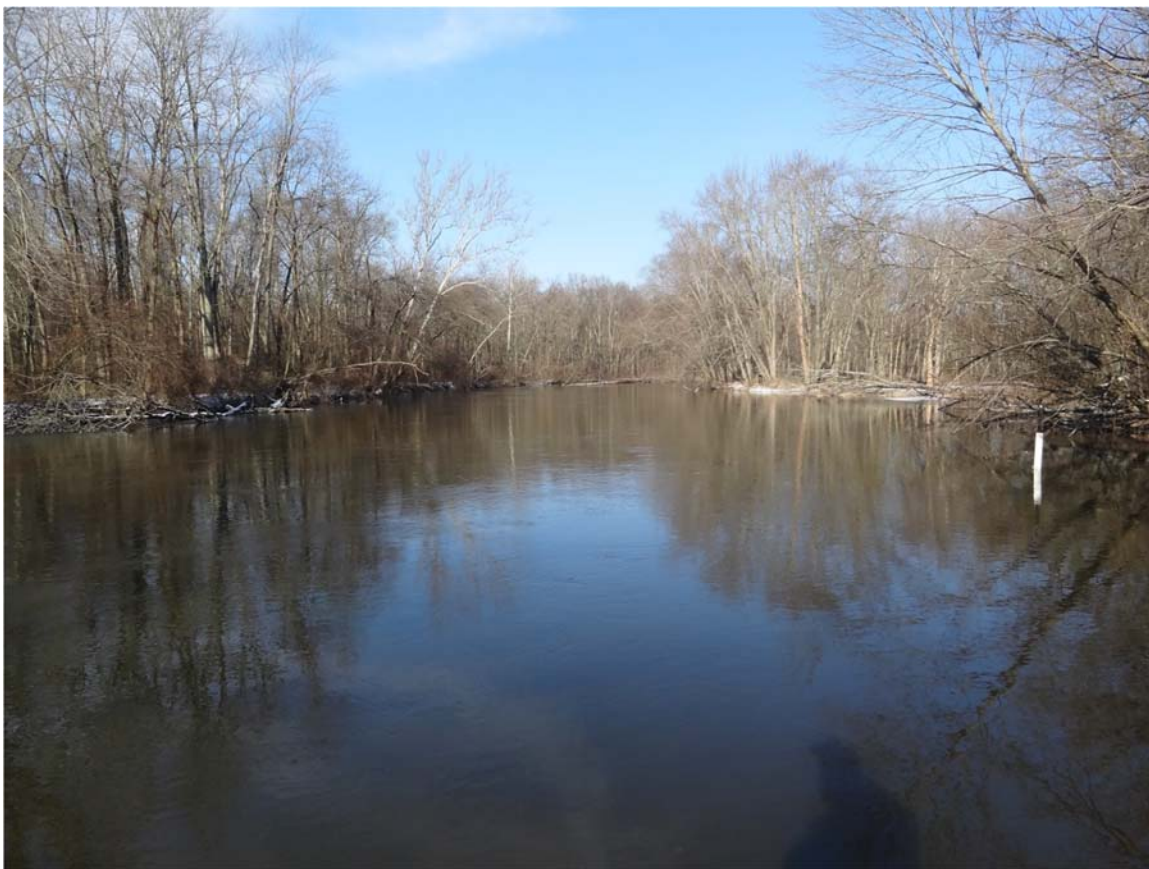
16. E2 Boat launch river conditions, no ice observed flowing within the river.

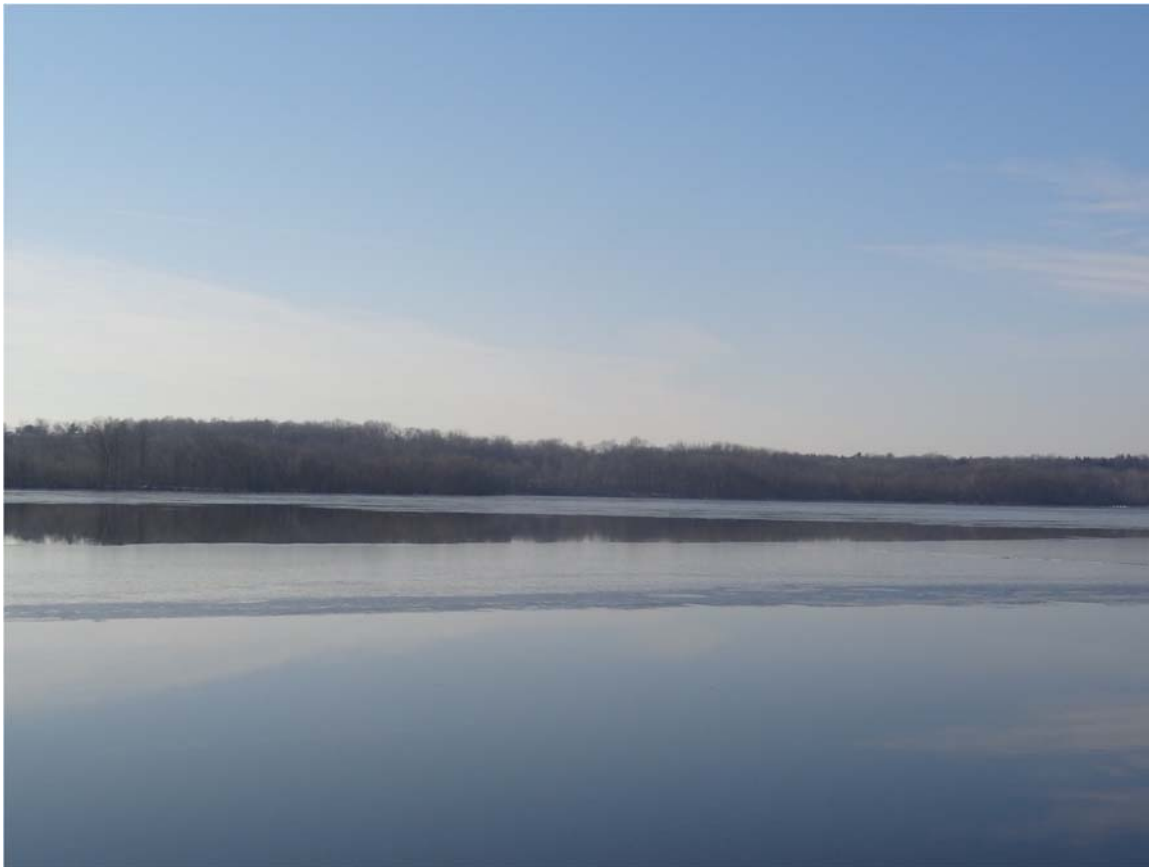
17. E4 Boat Launch Morrow Lake observed ice forming.

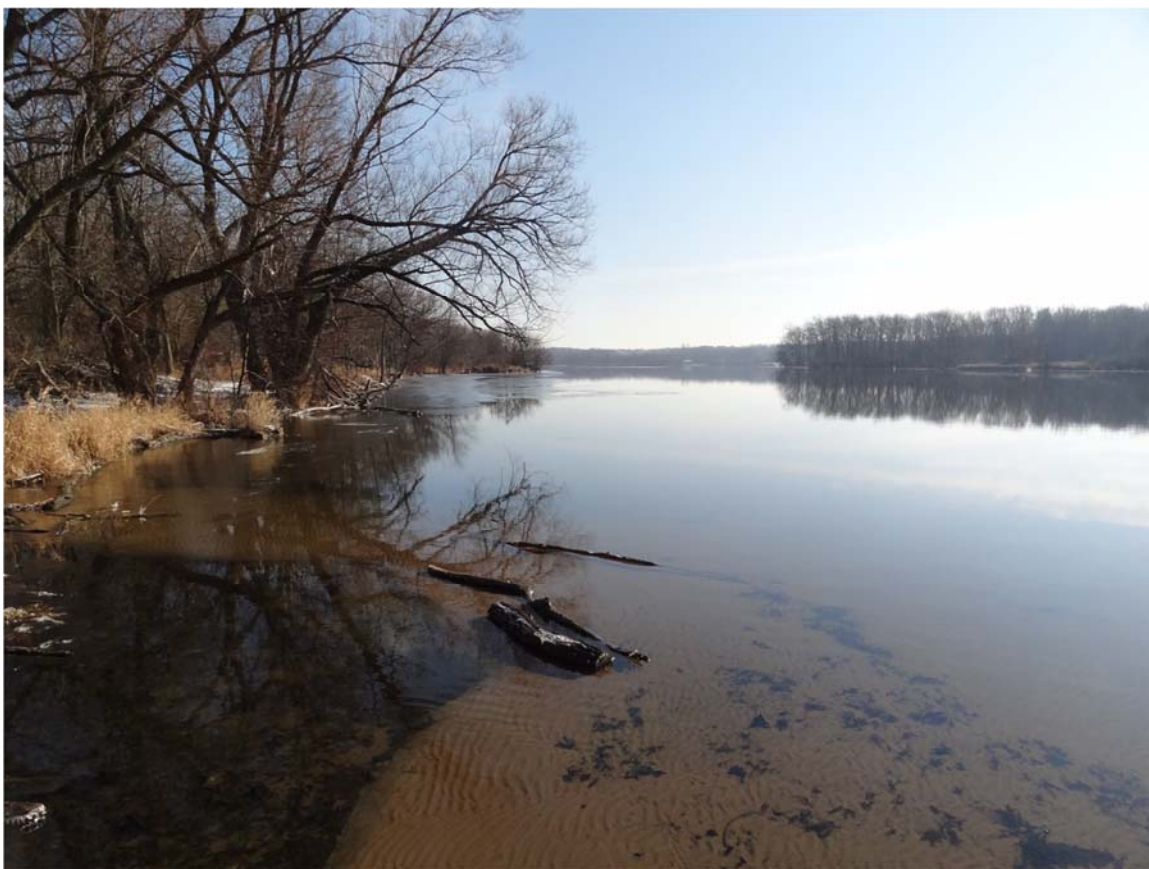
18. Morrow Lake Delta observed bank ice forming.

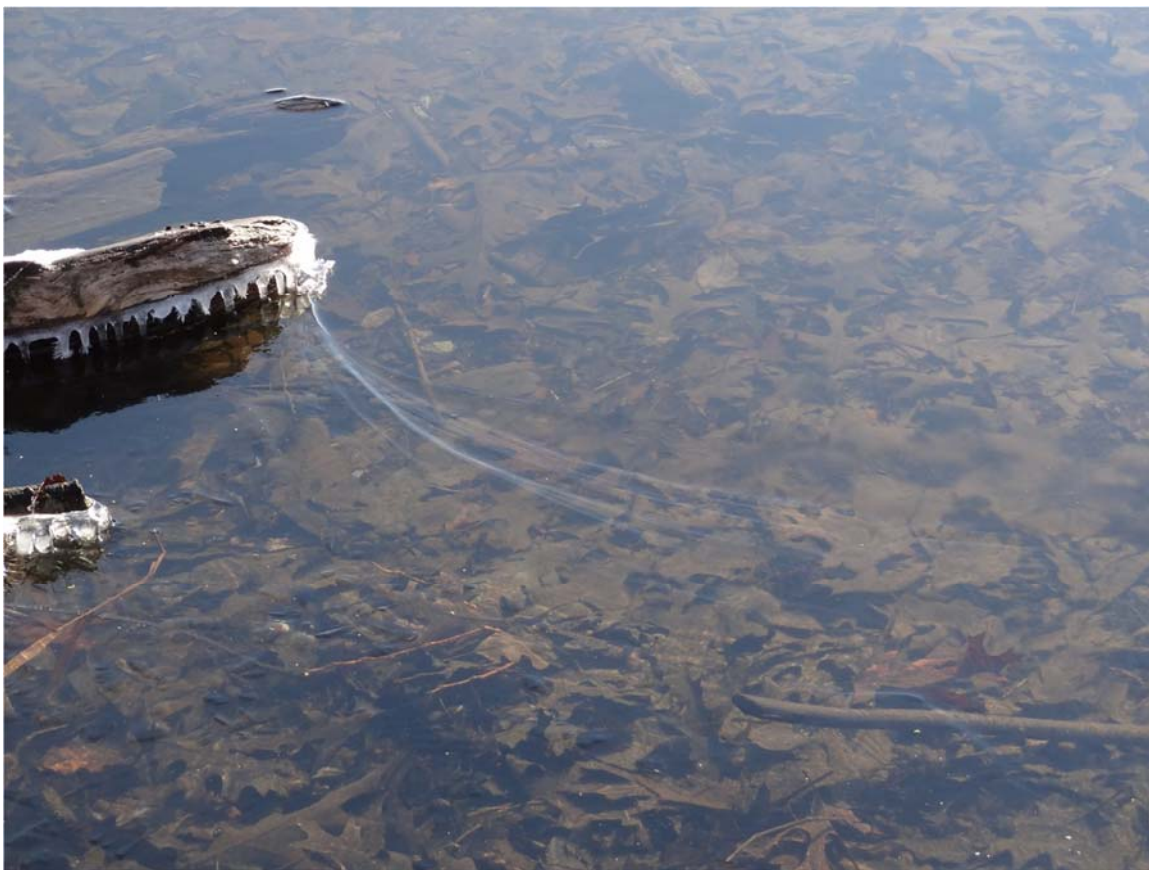
19. Morrow Lake Delta observed sheen frozen within the ice.

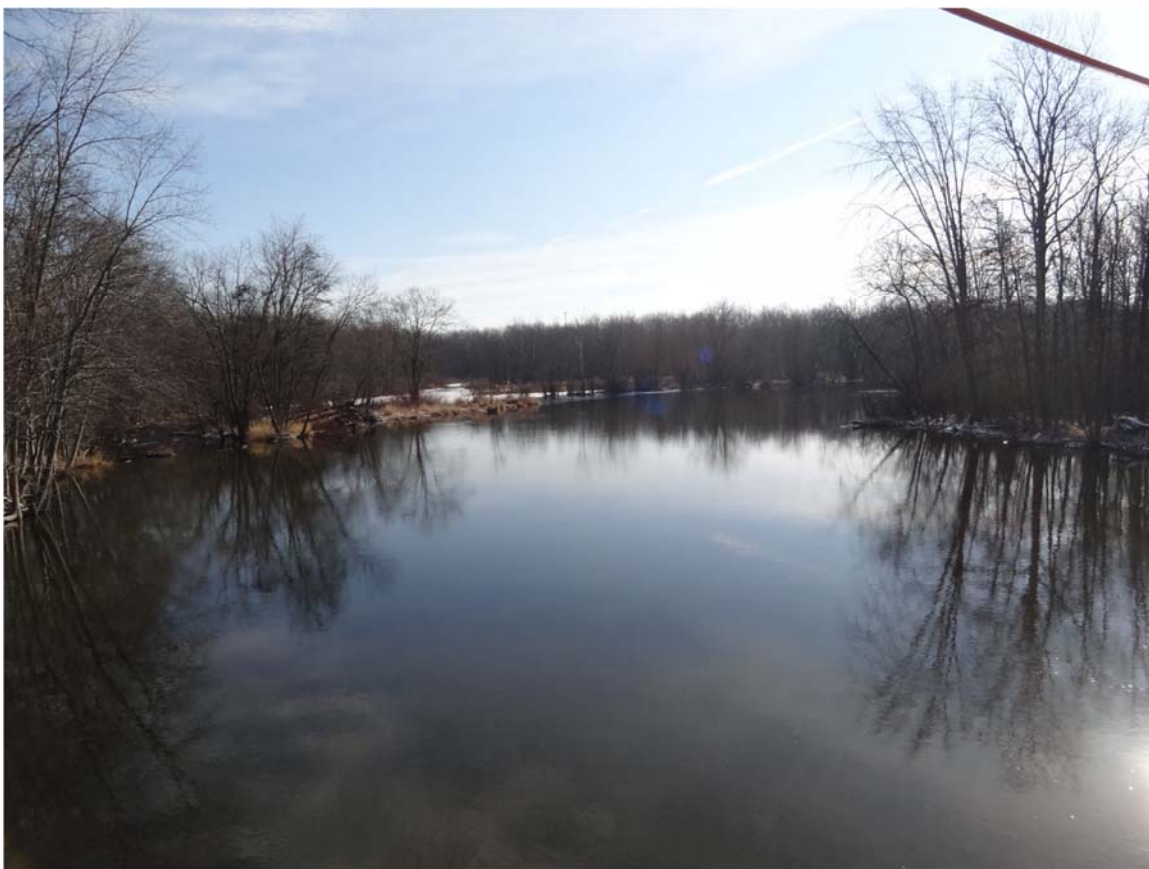
20. MP36.5 35th Street Bridge no ice observed flowing within the river.

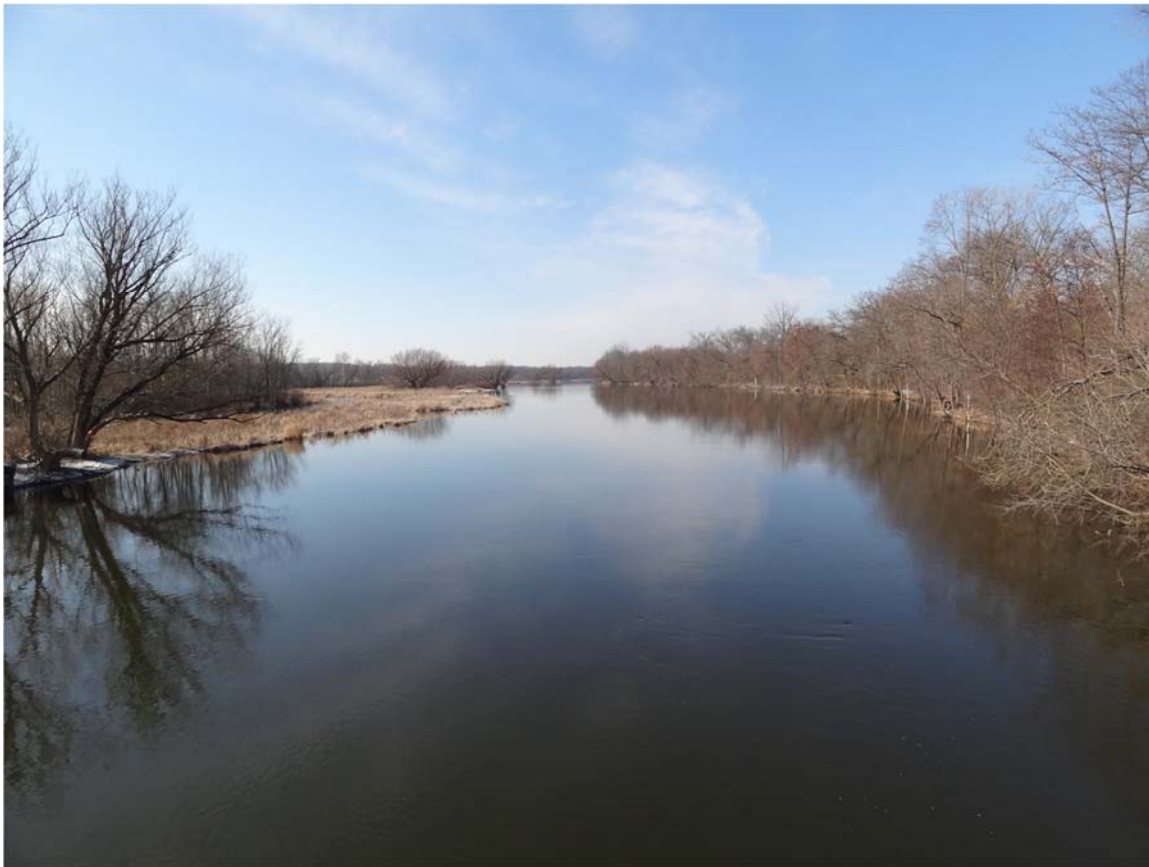
21. MP36.5 35th Street Bridge no ice observed flowing within the river.
